Investigation report

C 4/1998 M

ms GERDA, grounding outside port of Kotka, April 7, 1998

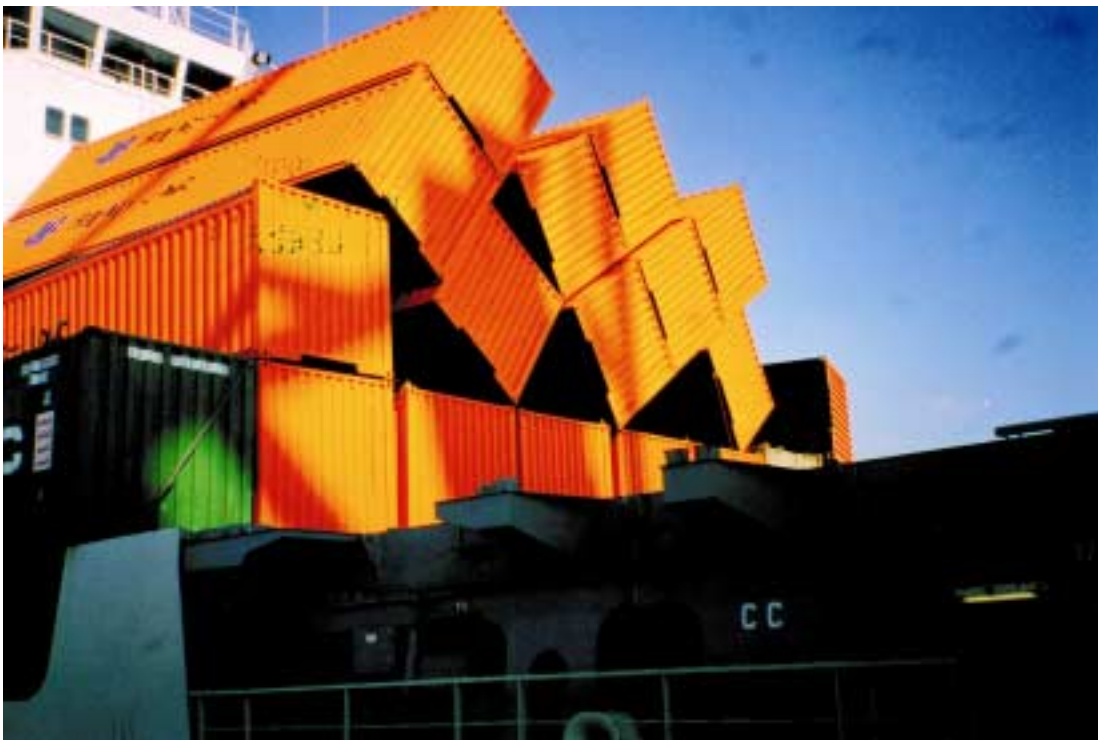
The GERDA listed violently to port from the force of the impact. The stack of containers in front of the bridge collapsed and four containers fell overboard. The master set the propeller pitch to zero. The autopilot was switched to manual steering and the helm was placed in the central position. The vessel came to a near halt. The pilot ordered compass heading 355°. The master 'kicked the engine forward' in order to turn the vessel. The engine room reported that there were no leaks.

Figure 5. Stack of containers in front of bridge collapsed on impact. Four containers rolled overboard.

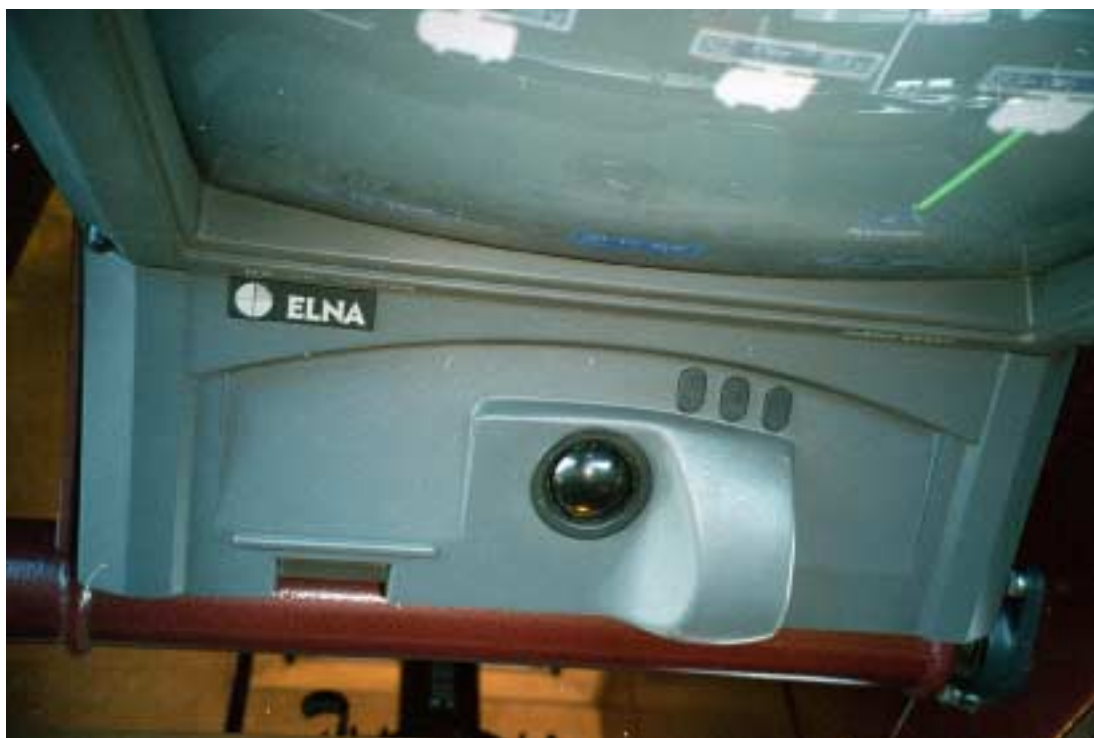
User interface of the Kelvin & Hughes radar. The Kelvin & Hughes monitor is generally considered to be a fairly good piece of equipment for open sea navigation in Europe. All functions are handled through menus with one rollerball and three buttons, which perform different functions according to the selected menu. The user interface of the radar is presented in Figure 9. The advantage of this system is the absence of all buttons and controls, but for the user this means multiple functions. The system is not functional for pilots, as it differs from other radars. The radars and steering equipment of a vessel the GERDA's type are analysed in accordance with the accident investigation of ms BALTIC MERCHANT (Investigation C 5/1998 M) based on piloting and the Rhein river traffic regulations. According to these regulations, the user interface of the Kelvin & Hughes radar is not acceptable. In the investigation of the BALTIC MERCHANT, the pilot clearly indicated that the user interface of the Kelvin & Hughes marine radar was slow to operate.

Figure 9. Keyboard of Kelvin & Hughes radar.

Summary of radars. The user interface of the Kelvin & Hughes radar on the GERDA differs considerably from radar sets of other manufacturers. This causes problems, especially for pilots, because they do not get the same opportunity to practice using the radar as the ship's officers. With regard to piloting, the radar adjustments are too complex and too slow to use. Pilots navigating in archipelagos and in ice have criticised the user interface.

The Rhein river traffic regulations contain provisions for the user interface of the variable range marker and electronic bearing, which could be applied to piloting under Finnish conditions. If the user interface of a radar is deemed unsuitable for piloting then a visibility limit must be set for the piloting.

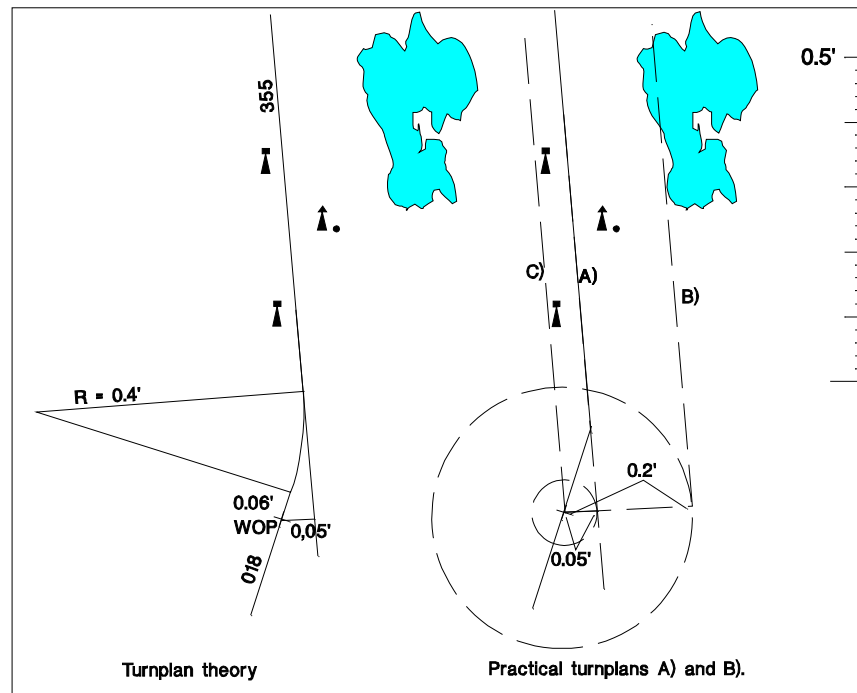
Figure 10. Use of bearing and range in piloting. Pirköyri turn as example.

The Pirköyri turn is planned for turn radius of 0,4' and is begun 0,064' before the start of the even turn. The WOP (Wheel Over Point) provides the starting point for the turn. There are two alternative bearings, A and B, parallel to the new heading which can be used for defining the starting point for the new turn. Lateral distances 0,05' and 0,2' can be read from the chart.

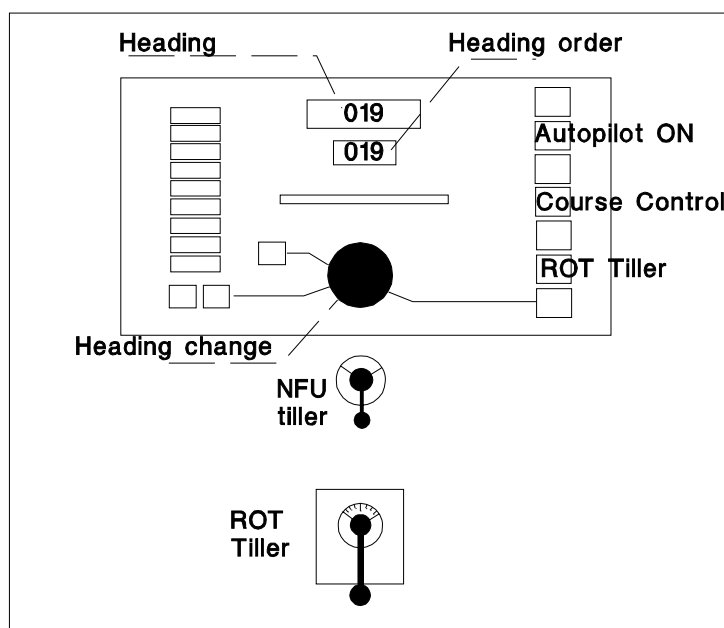
The **ROT Tiller** is a steering mode designed for river traffic. It has not been designed to be used by the helmsman but by the person navigating the ship. Steering by rate of turn releases the hands for other navigation equipment and allows for concentrated observa-

Figure 11. Steering modes for Anschütz Nautocourse D system suitable for piloting. NFU was emergency steering.

The autopilot equipment on the GERDA was good. The ROT Tiller of the Anschütz Nautopilot system is especially well-suited to piloting. However, this steering mode was not used. The bridge had NFU steering for manual steering. A better system for steering manually is FU steering, but this was missing from the GERDA.

The user manuals of all commonly used radars and autopilots should also be made available to pilots. The autopilot modes should be summarised in a brief procedural manual for piloting. The ROT Tiller steering method should always be used during piloting. The course control mode is designed for cruising on open seas: it can be used on long straight lines but not on winding fairways. Training should be organised for pilots to explain the user modes of autopilots and the risk factors involved.

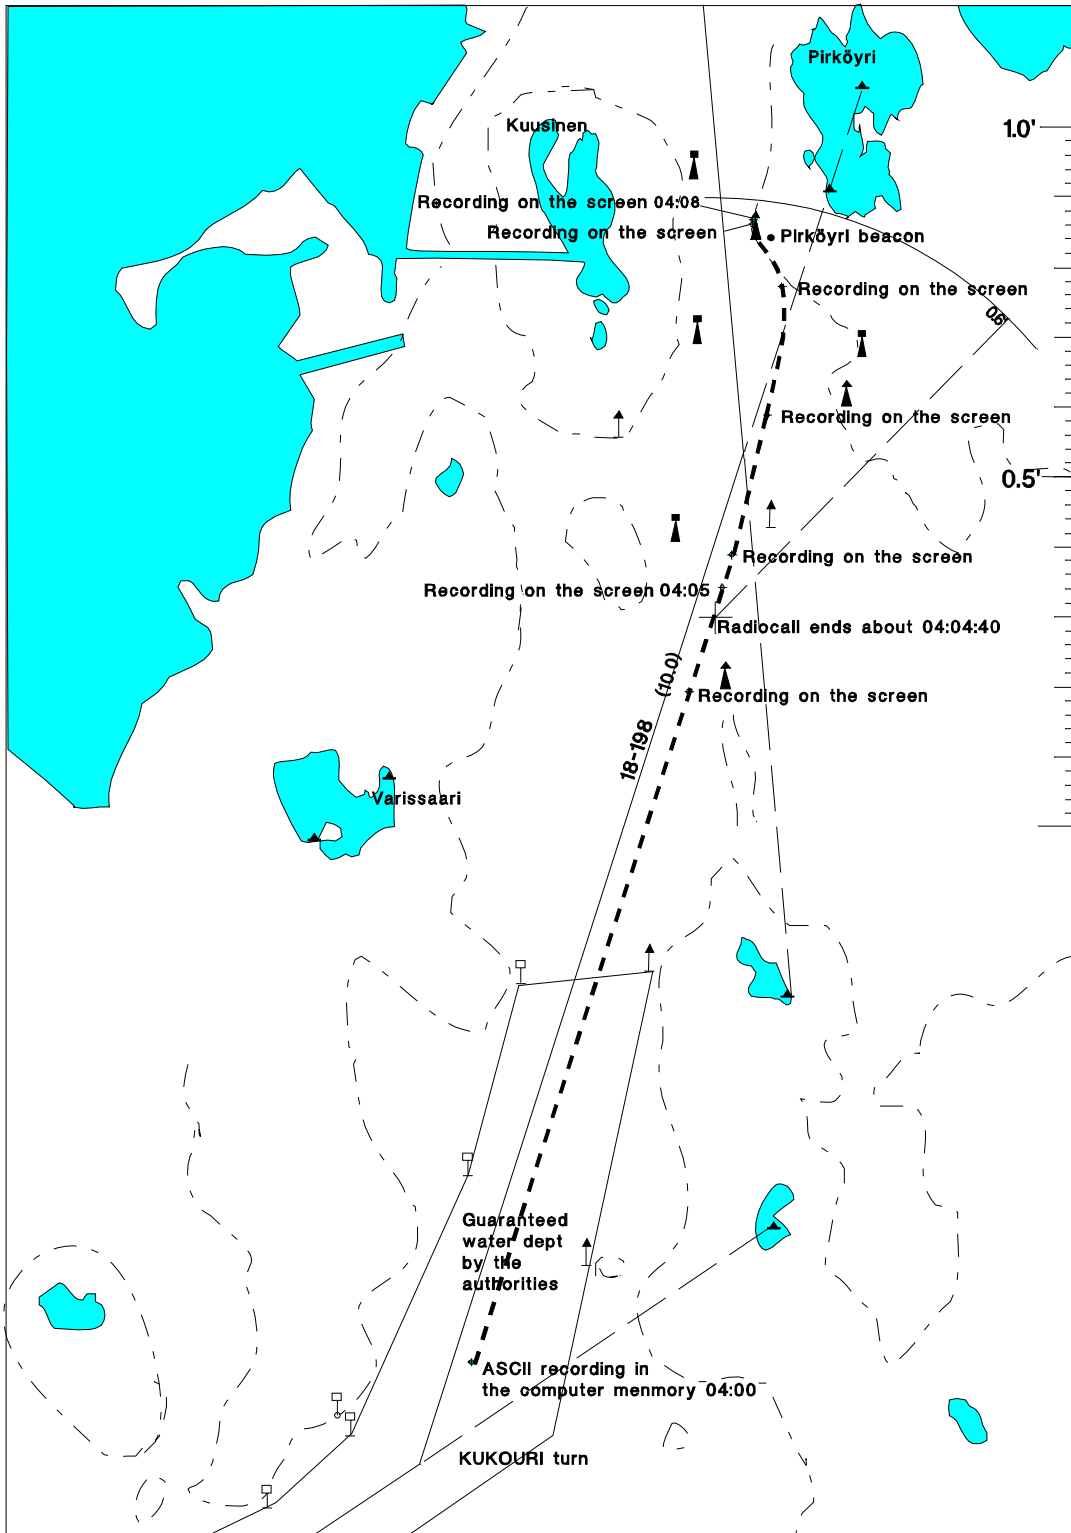
Figure 13. Passage of GERDA traced from electronic chart. Chart was photographed after grounding. Vessel position and times registered automatically on chart at 1 minute intervals. Grounding site next to Pirköyri beacon.

According to the GPS registration (position points recorded on the electronic chart), the GERDA had passed the Halla – Kukouri line (355°) at a speed of about 11–12 knots before the turn to heading 360° began (Figure 13).

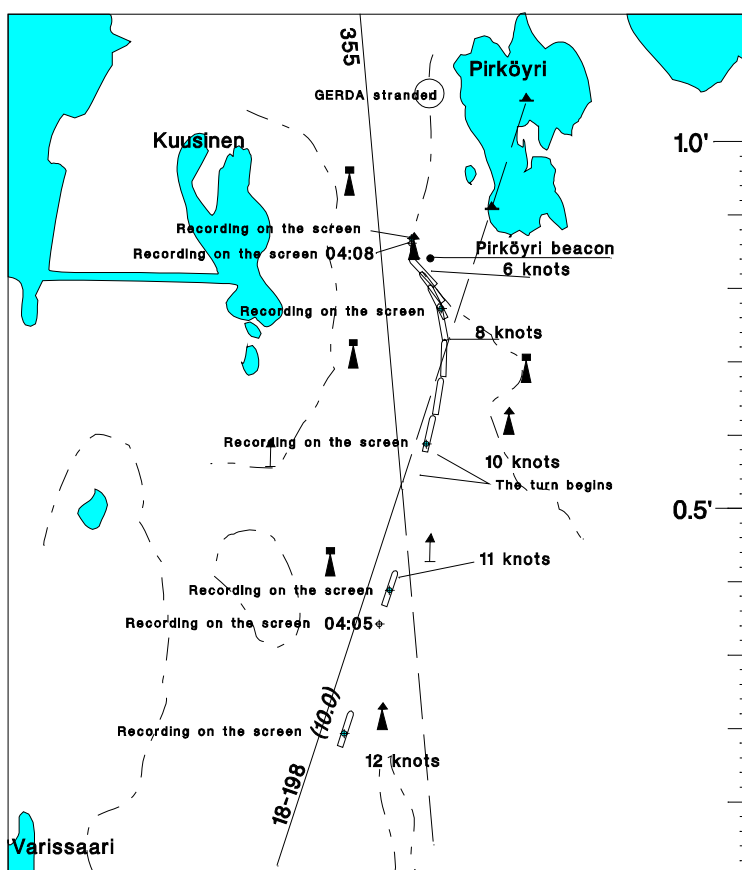
Figure 14. Accident turn simulated in open water. Ring around resting place of GERDA describes error in positioning (about 45 metres).

When simulating the accident turn with a model of a container ship of 95 metres length in open-sea conditions, it is difficult to make the vessel turn within a radius of 2 cables (Figure 14). The drifting angle presented in Figure 14 for the vessel may not be essentially correct due to the ice. The series of registrations depicting the steep turn on the electronic chart points to there being no obstruction from the ice in the turn. It is possible that the turn has been slightly more rounded than that in the GPS registration because, when the GERDA lay stationary on the shore at Pirköyri after the grounding, the GPS drew a positioning error of about 45 metres around the vessel (Figure 14). Figure 15 presents the reconstructed trajectory of the vessel and the possible location error. Errors caused by transfer of the location from photograph to chart, and the possible effects of ice on the turn, are included in this. It is possible that the differential signal broke off at about 04:07. The speed of the GERDA decreased, starting from Varissaari, but due to the positioning error it is impossible to determine her speed very accurately. Analysis shows that the turn (start of the turn) was about 0.3' late.

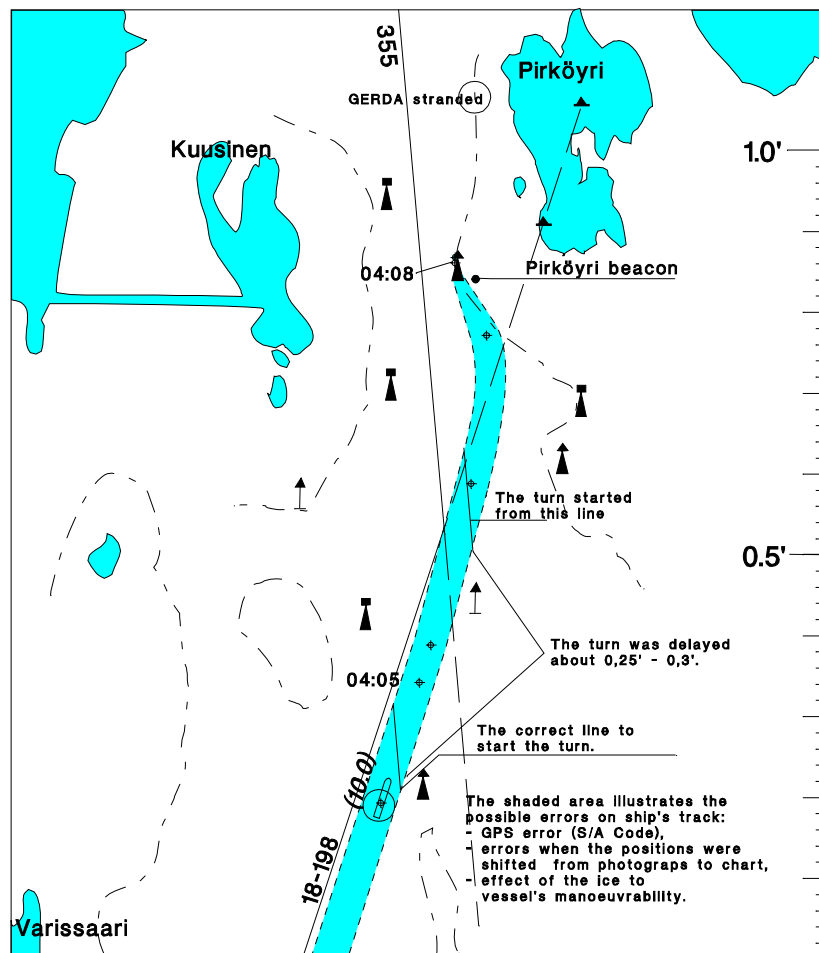
Figure 15. Inaccuracies in trajectory of vessel. Grey area describes possible error in positioning.

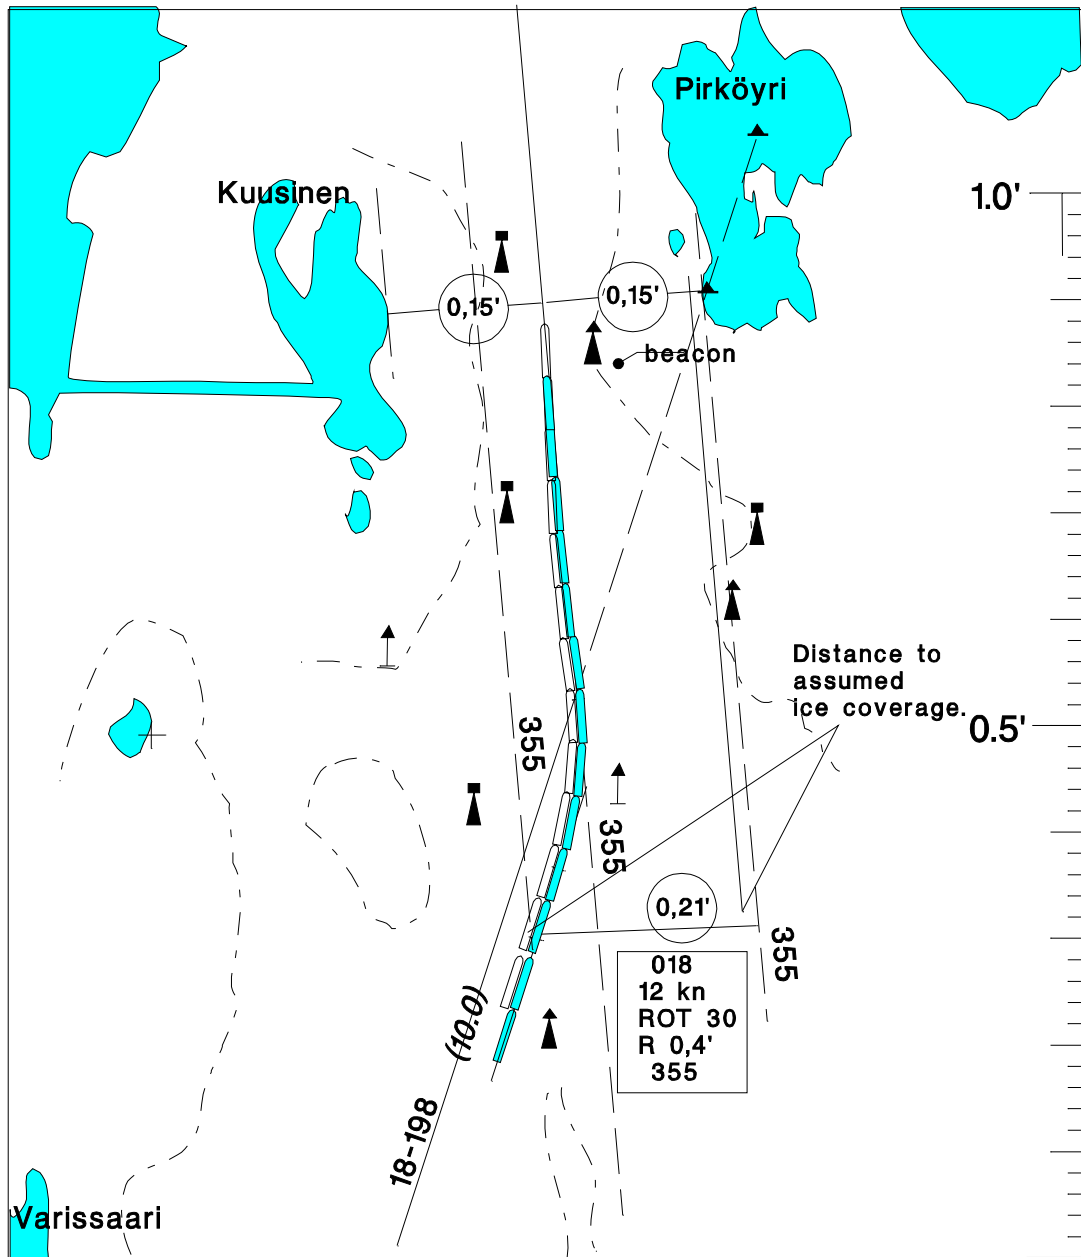
The radius of the turn is 0.4', and the starting point 0.06' before the start of an constant turn (Figure 16). Value 0.21' is set on the VRM ring and 355° is set for the EBL heading as tangent to the ring. The turn is started when the EBL touches the shore of Pirköyri. The pilot stated that there was packed ice at the Pirköyri shore interfering with the definition of the turning point. The assumption in Figure 16 is that the ice has shifted the shoreline 30–40 metres, which would have resulted in a similar shift to port in the trajectory of the vessel. The error could have been easily corrected with a heading of 355° before the Pirköyri Sound. The two parallel vessel trajectories depict the error caused by the ice on the shore.

In a written passage plan, the turn parameters are marked in a clearly visible box next to the turn (example in Figure 16). At the beginning of the turn, the rudder angles are 10°–20°. The rudder angle is adjusted so that the rate-of-turn indicator shows 30°/minute.

Figure 16 Example of Pirköyri turn plan.

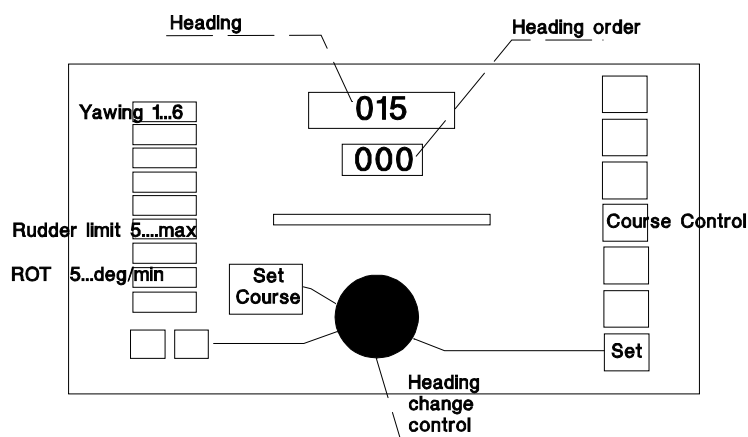
Figure 17. Main controls of COURSE CONTROL mode of Anschütz Nautopilot D in piloting:

- YAWING 2
 - Rudder limit 35°
 - ROT (rate of turn), for example 30° / min.
- Set Course and heading change knob set direction. Set command initiates preset turn.

The Course Control is thus susceptible to mistakes but it is not designed for navigation on winding fairways. The ROT Tiller is designed for that.

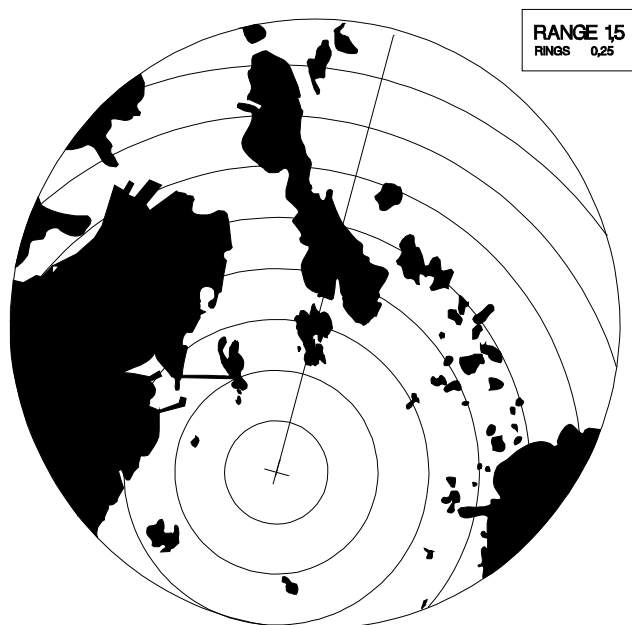
It is possible that the pilot made an error with the distances between the fixed rings on the radar when preparing for the turn. He could not use the variable range marker because the only user interface for the radar – the rollerball – was reserved for the adjustment of the radar image, which the pilot tried constantly to improve. If the southern tip of Pirköyri pierced the second range ring it is possible that the pilot erroneously thought that the first ring depicted a range of 0.5' instead of the actual range of 0.25'. This may

explain why he did not begin the turn at the location presented in Figure 18. The distance between the rings (RINGS) is expressed in the upper right-hand corner of the radar in smaller print than 'range' (RANGE).

Figure 18. Range of radar 1,5', distance to Pirköyri 0,6'. Turn should have begun here.

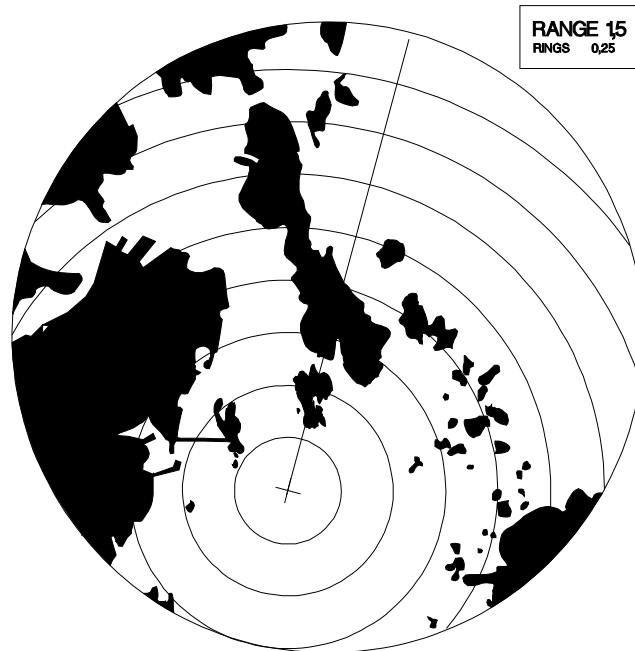
Figure 19a. Distance to Pirköyri about 0,3'. Range of radar still 1,5'. Turn to heading 360° begins.

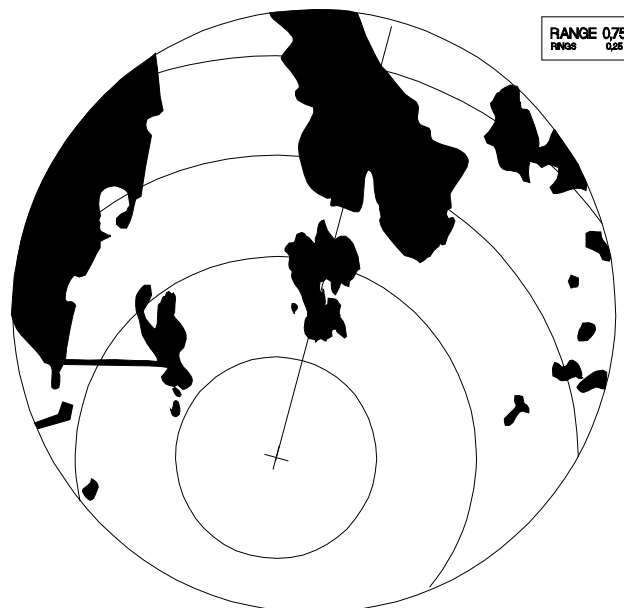
Figure 19b. Distance to Pirköyri about 0,3'. Range of radar changed to 0,75'.
