Class B Accident Report

Aratere & Kent Close Quarters

Wellington Harbour on 1
October 2004

REPORT NO: 04 3559

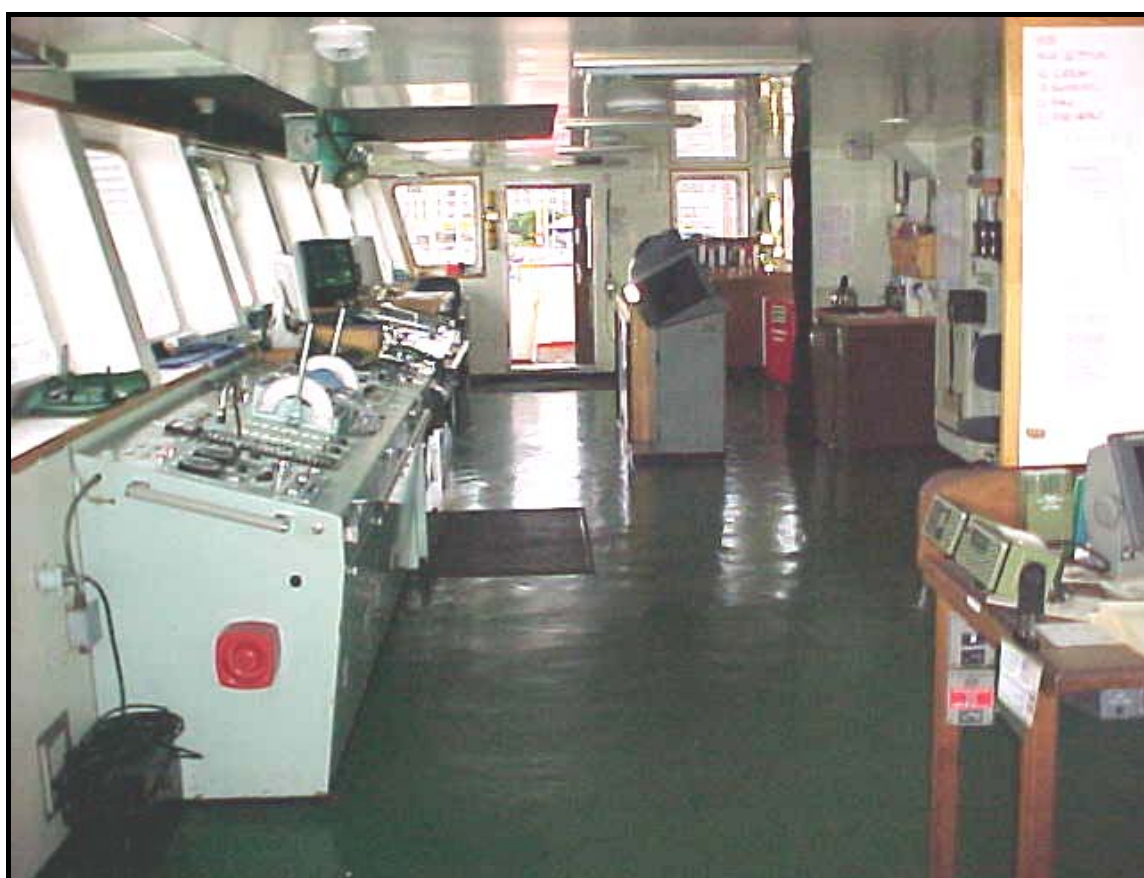
PHOTOGRAPH 1 - BRIDGE OF *KENT*

The weather was a light northerly breeze of 10 knots, fine and clear. It was forty seven minutes before predicted high water springs and charted information indicates a flood tide of approximately 0.1 knots was running at the time. *Kent* was being steered by automatic pilot. The Master and Watchkeeping Officer were on the bridge, but there was no helmsman present. The Master monitored the automatic steering.

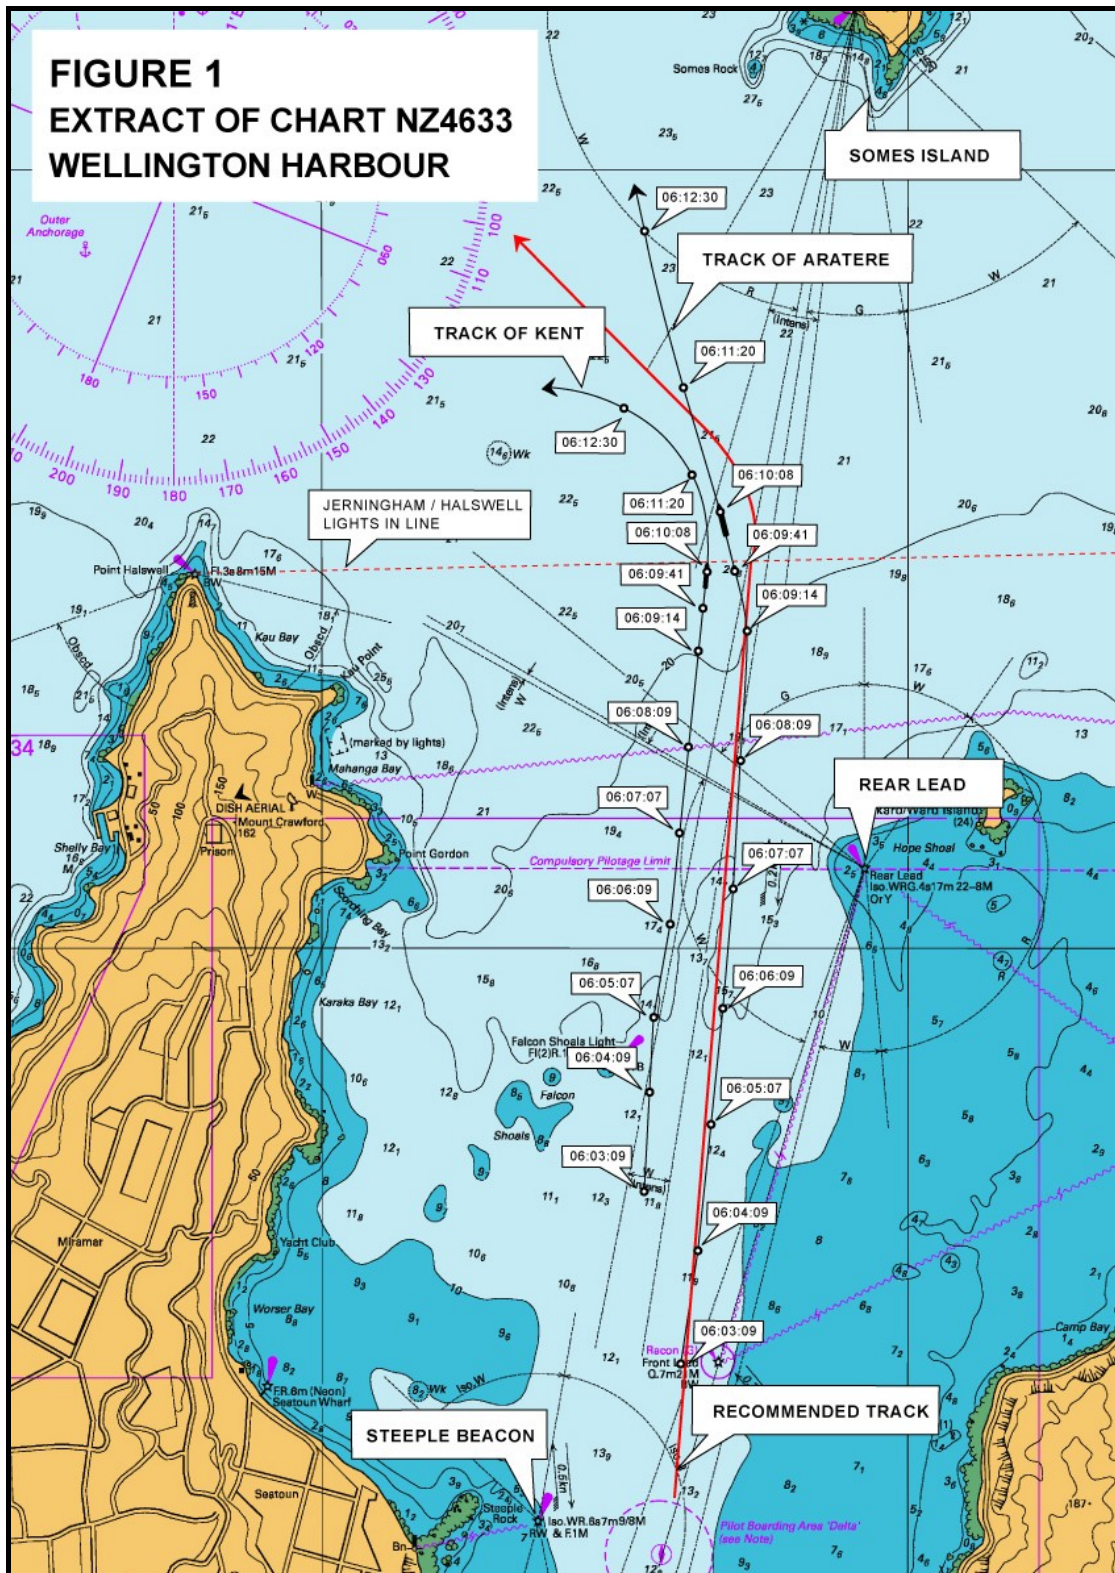
FIGURE 1 – CHART EXTRACT

At approximately 0559 hours, shortly before passing Steeple Beacon (*See Figure 1 – Chart Extract of Wellington Harbour, showing a plot of Aratere and Kent, based on VDR [Voyage Data Recorder] information from both vessels*), **Kent** altered course to port onto a course of 006°(T), moving towards the western side of the navigable channel to give **Aratere** more sea room (*See chart extract for Kent positions 06:03:09 to 06:05:07*).

The Master of **Aratere**, in his interview with the MSA, stated they passed **Kent** about half way between Falcon Shoals Beacon and the Rear Lead (*See chart extract*), approximately 2 cables south of the Rear Lead. This is contrary to the VDR evidence, which shows the two vessels were abeam of each other when approximately 4 cables north of the Rear Lead. The Master of **Aratere** confirmed his vessel was within a few metres of her programmed track (*See chart extract, positions for 06:08:09*).

At 0609 hours, when the stern of **Aratere** was just forward of **Kent's** bow and **Aratere** was pulling away at a relative speed of 5 knots, **Aratere** commenced turning to port. The Quartermaster was instructed to steer 345°(T), an alteration of 20 degrees to port from her previous course of 005°(T). The recommended wheel over position on this leg of a vessel's inward passage (which was used by **Kent**) is when Point Halswell and Point Jerningham are in line (*See chart extract*). The Master of **Aratere** stated in his interview with the MSA Investigator, a week after the incident, that **Aratere** was two cables north of this transit before he commenced altering course to port. He stated he had delayed making the alteration because of the presence of **Kent**, but did not wait until **Kent** altered to port, which occurred at 0610 hours, as he did not wish to approach any closer to Somes Island (*See chart extract*), which was ahead of him.

When **Aratere** made the alteration of course to port, VDR information indicates the 10 metre sounding contour, to the south of Somes Island, was situated 1.38 miles distant. At a speed of 19 knots, this would have taken **Aratere** four minutes to cover.

If *Aratere* had delayed altering course until *Kent* had started to alter, after reaching the recommended wheel over position on the Halswell/Jerningham transit line, *Aratere* would have had a distance to run to the 10 metre contour south of Somes Island of 1.06 miles, which would have taken just over 3 minutes to cover at a speed of 19 knots.

However, reference to the radar images taken from *Aratere*'s VDR information shows she was in fact 1.8 cables south (*MSA emphasis*) of the Jerningham/Halswell transit line when the above alteration of course to port became apparent on the radar images (*See chart extract, position of Aratere at 06:09:14*). At the time when the Master altered course 20° towards *Kent*, the stern of *Aratere* was just forward and some 260 metres to starboard of *Kent*'s bow. This occurred one minute before *Kent* reached the recommended wheel over position.

The chart plot shows that the CPA, between the bow of *Kent* and the stern of *Aratere*, was 125 metres. Information from the shore-based surveillance radar at Beacon Hill Signal Station, situated at the entrance to Wellington Harbour, indicates that the separation was 137 metres.

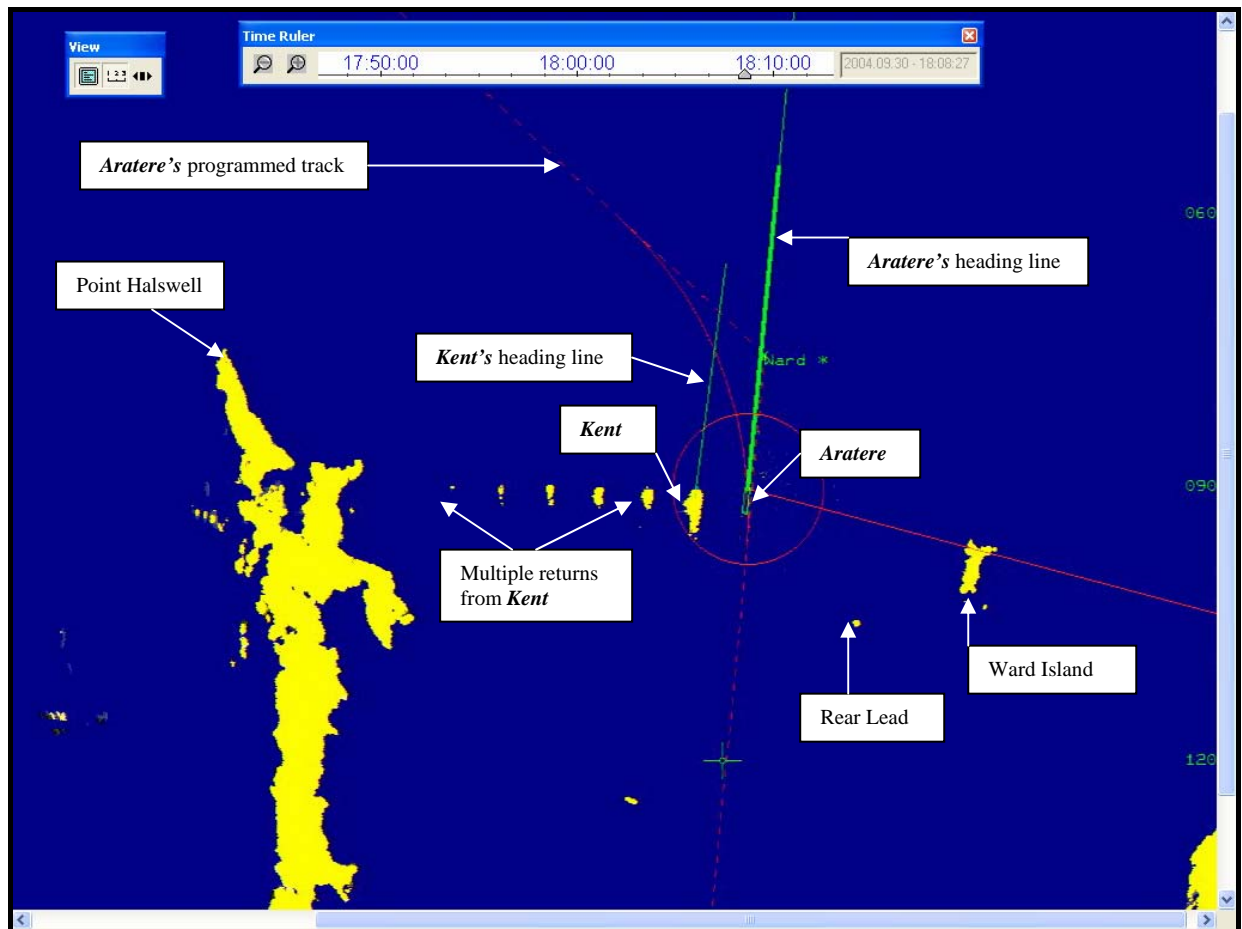
FIGURE 2

At 0608 hours, when **Kent** was just north of the Rear Lead (*See chart extract and Figure 2*), **Aratere** passed abeam of **Kent** at a distance of 1.4 cables (260 metres) on her starboard side. **Kent** still had approximately two minutes to run to her next designated alter course position, which is marked by the transit of Point Halswell and Point Jerningham (*See chart extract*). **Kent** was west of her normal inbound track by about 1.4 cables. **Aratere** was on her normal inbound track as **Kent** had allowed sufficient sea room not to require a deviation of her course. **Aratere** was steering a course of 005°(T) (*See chart extract, positions for 06:08:09*).

Figure 2 above, represents *Aratere's* VDR radar picture taken at 06 08 27 hours (NZST), when her Master gave the order to steer 340°. This equated to an alteration of 25° to port of the course she was steering at that time (005°). At this stage, *Kent* is only just abaft *Aratere's* port beam. The echo from *Kent* is extended by returns from the side lobes as well as the main radar beam.
