Investigation report

C 4/1998 M

ms GERDA, grounding outside port of Kotka, April 7, 1998

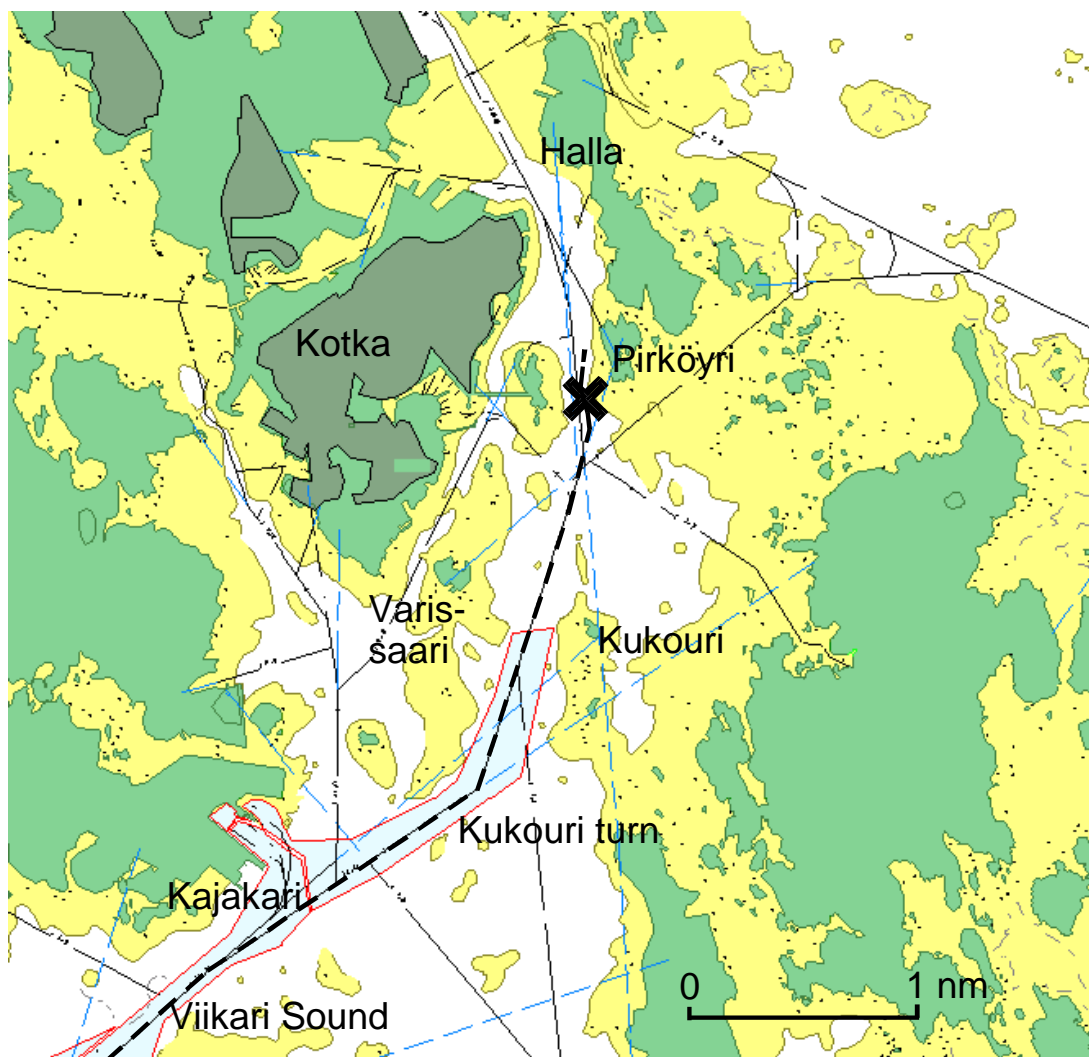
Figure 4. Fairway from Viikari Sound to Pirköyri used by the GERDA

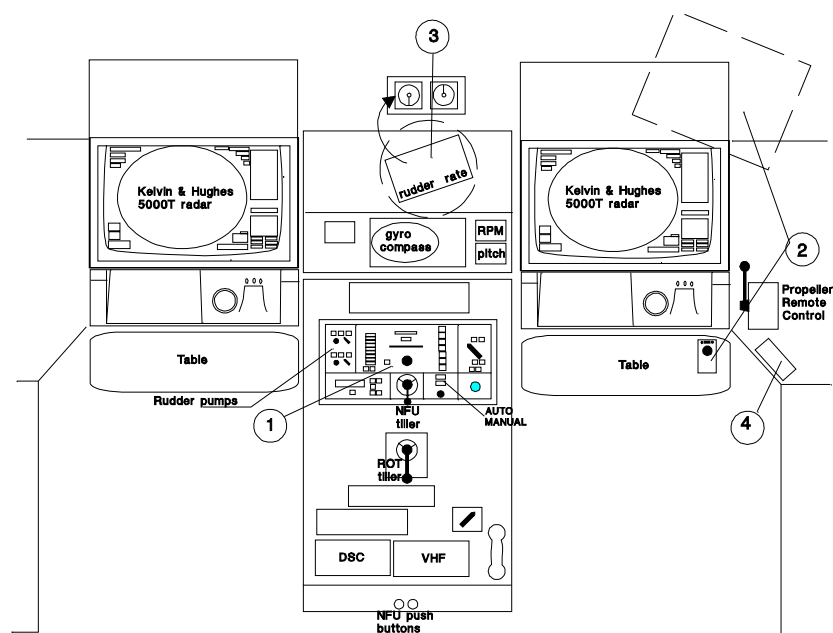
1. *Anschütz Nautopilot D.*
2. *Electronic chart. Used with mouse in front of radar.*
3. *Combined turntable rate-of-turn and rudder-angle indicator.*
4. *Central unit for horn.*

Figure 6. Cockpit arrangement and location of equipment of ms GERDA. Figure drawn from photographs.

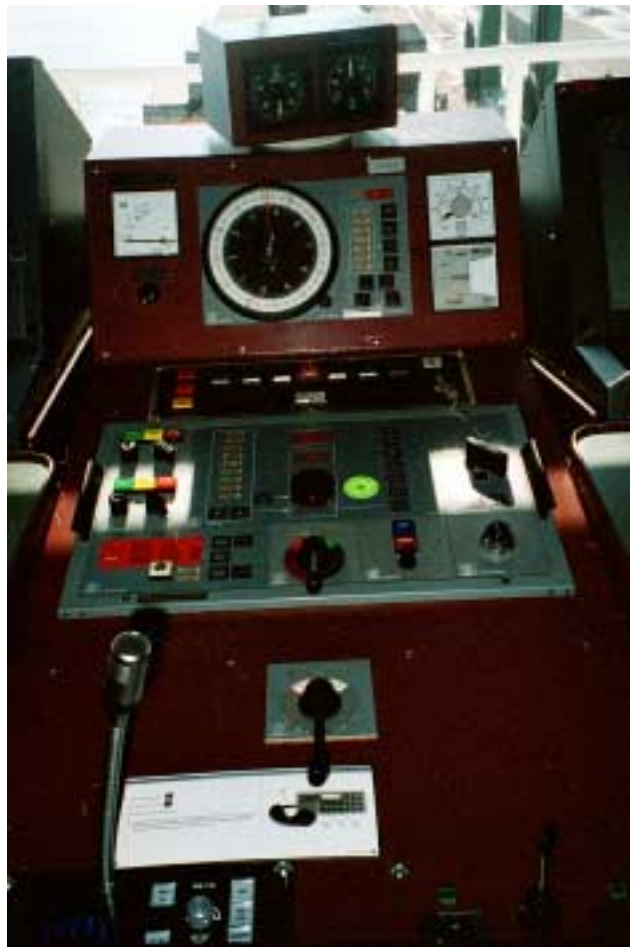
Figure 8. Middle cockpit console with autopilot and rate-of-turn and rudder-angle indicator (see also Figure 6).

The pilot and the master had two feasible steering methods in the Anschütz Nautopilot steering system, which is designed for both open-sea and river traffic. In addition, the middle console had manual steering of the rudder (NFU), which is mainly suited for emergency steering. This equipment is pictured in Figures 8 and 11. The steering methods are:

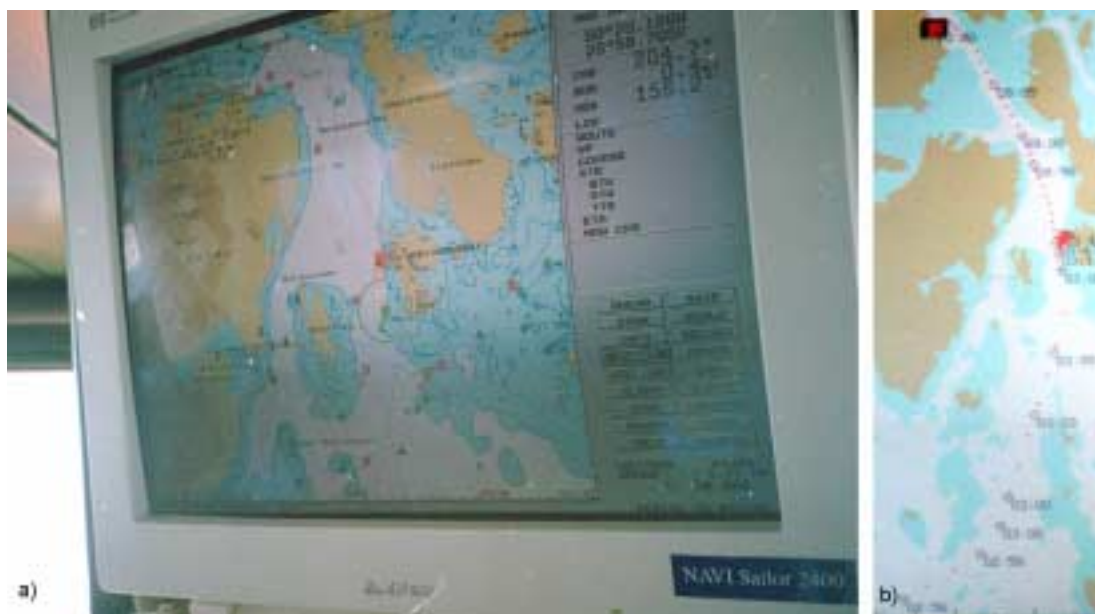
which is detectable from the registration at about 04:05 (Figures 12b and 13). The pilot conducted two radiotelephone conversations concerning traffic with the port authority and with ms INOWROCLAW. The last call ended at about 04:04:40 according to the reconstruction. The time is based on the fact that at the end of the call he measured 0.6' as the distance to Pirköyri. The speed was 12 knots. At the end of the call the vessel was near the point where the Pirköyri turn should have been resolutely initiated with a rudder angle of 15°–20°.

Figure 12. a) Monitor for electronic chart mounted in the ceiling (see also Figure 2).

b) Route points of GERDA registered on chart.
